## SERVICE BULLETIN

This bulletin is to advise Cobalt-60 source users about the potential for excessive wear to the source assembly from using an improperly maintained remote control drive cable in the radiography system.

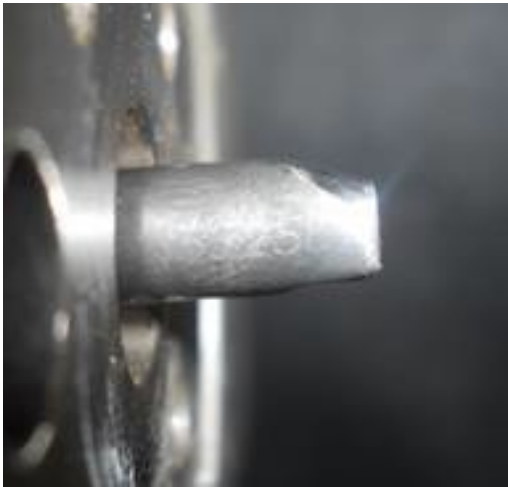
Recently, QSA Global was notified by a few international users regarding unusual wear to the source connector on the Model A424-14 source assembly. Also, during this same time period, QSA Global noticed an increase in unusual wear on a few older Cobalt-60 source capsules that were returned for disposal.

**Excessively Worn Source Connector**

QSA Global conducted an extensive investigation into the issue to identify the cause of the wearing. The investigation found, in these cases, that inadequate lubrication, lack of maintenance and severe environmental conditions can lead directly to excessive and unusual wear on the source assembly. Examples of severe environmental conditions include use of equipment in and around desert sand, casting foundry sand, fly-ash in coal generation plants and other environments as listed in the device manuals.

- Clean and lubricate the remote control drive cable according to the operating and detailed maintenance instructions in the device manuals. Ensure that the recommended cleaning solvent and lubricants are used for all QSA Global remote control drive cables. Refer to the specific product manuals for these instructions.
- Remember that exposure cycles beyond 10,000 cycles before the three month maintenance interval should prompt remote control drive cable cleaning, inspection, and lubrication.
- Use only QSA Global supplied or approved parts and components in the radiography system. The use of third party (“copy”) repair parts and components on QSA Global, Inc. industrial radiography equipment might also unknowingly contribute to the source assembly wear as well as invalidate the associated Type B, Type A and/or the ISO 3999 certifications of the respective equipment.

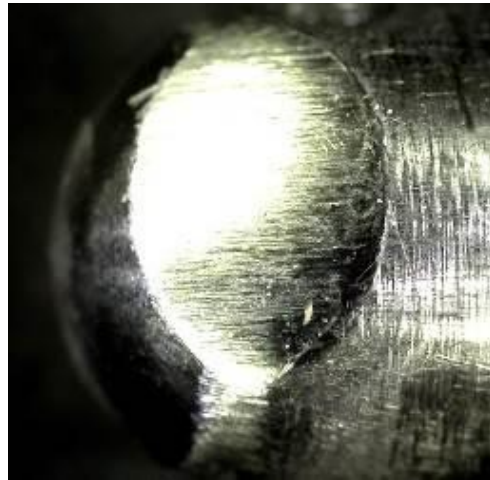
**Unusual Wear on Source Capsule**
